RAILWAY INVESTIGATION REPORT

R02Q0021

MAIN TRACK DERAILMENT

QUEBEC NORTH SHORE AND LABRADOR RAILWAY

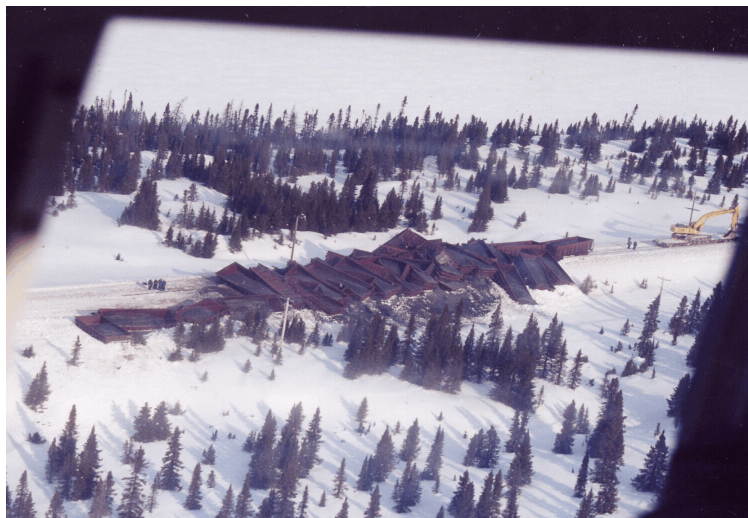
The derailed cars were lying accordion style and piled up on top of each other, forming a heap of scrap and iron ore on the right-of-way (see Figure 1). Thirty-three cars were destroyed and seven cars were seriously damaged. About 300 metres of track was damaged. The weather was clear and the temperature was -12°C.

Figure 1. Overview of the accident site

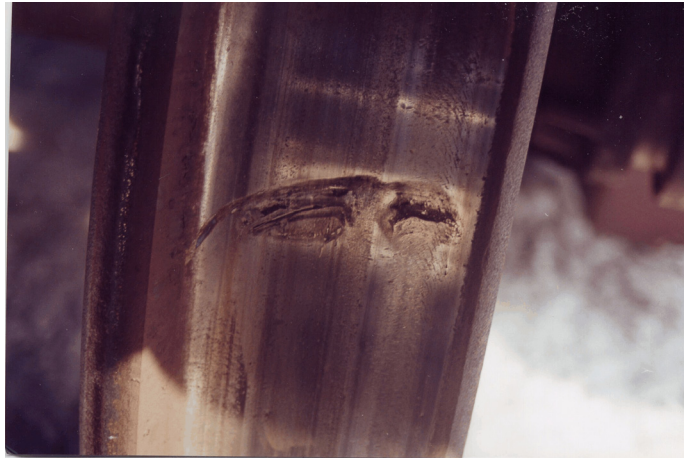
An examination of the cars revealed that the wheels on the east side of the cars preceding the 25th car (17th to 24th cars) had a mark across the wheel tread (see Figure 2). No other mechanical defects were observed on the cars.

Figure 2. Mark on the wheel tread

The wheel flange marks visible on the ties at the point where the destruction of the track started continued up to the first derailed car. In addition, the mark on the wheels on the east side of the cars preceding the derailed cars confirmed that the east rail broke under the 17th car as train PH 187 passed.

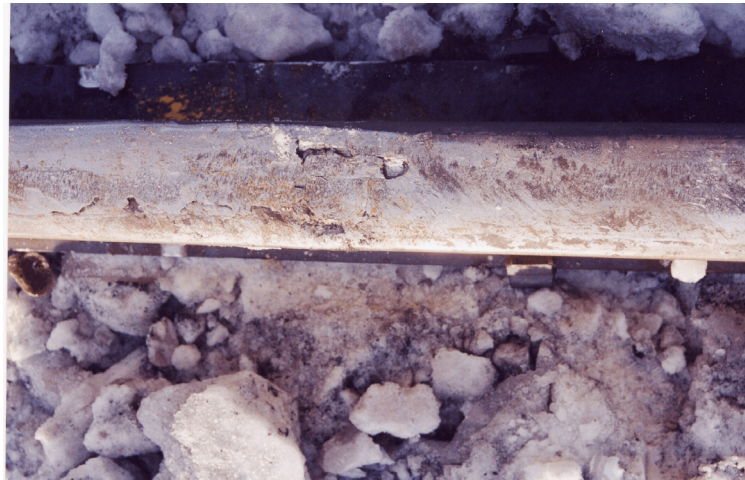
At approximately Mile 139.33, where the destruction of the track started, the rail had a crushed head (see Figure 3). This surface defect was noted in the inspection of 05 February 2002 and was categorized as "priority 1." A few feet south of this defect, the rail was broken under the last derailed car. Four pieces of broken rail, two pieces of rail head and two pieces of rail base were recovered and sent to the TSB Engineering Laboratory for analysis. There were no wheel flange marks or marks from dragging parts to the north of where the rail was broken. Wheel flange marks were visible east of the track, leading to the first derailed car.

Figure 3. Crushed rail head

Examination of the rail by the TSB Engineering Laboratory (report No. LP 030/02) indicated that wear of the rail was minimal. The rail head surface showed signs of light shelling on the interior side of the head. Tests on rail specimens showed that the rail had a maximum tensile strength of 171 ksi.¹ The hardness of the rail head surface approached a Rockwell C hardness of 42 (or Brinell 393) in the first 0.7 mm; a surface hardness of this magnitude is normal and is due to strain hardening of the surface layer of the metal.

The laboratory tests revealed that there were no pre-existing cracks in the rail specimens and that the break occurred quickly, and everything indicates that the rail broke suddenly as the train passed. The fracture pattern observed on the rail specimens indicates that a fracture started at the rail head surface and coincided with the edge of the creep on the rail that acted like a stress raiser. The high tensile strength and relatively high hardness measured on the rail specimens are properties indicating a material that is sensitive to the initiation and development of internal flaws; thus, the rail was sensitive to impacts from the wheels, especially in cold weather.

In addition, special visual inspections had been conducted to identify rail defects. The defects had been assessed according to their severity and repair work had been planned accordingly. However, the relatively high number of crushed heads—an average of about two defects per mile of track between Mile 130 and Mile 150—did not allow the repair teams to complete the repair work as planned.

QNS&L implemented a system to follow up on the priorities and to control risks in order to correct the most priority defects. Criteria acceptable for rail defects were tightened; for example, the acceptable limit for crushed heads went from 13 mm to 7 mm.

The company will develop an action plan and a preventive maintenance program to correct surface defects by controlling the wheel-to-rail interface dynamics. Under this initiative, 45 new rail lubricators will be installed and put in service, a wheel reshaping plan will be put in place, a wheel-shaping tower will be purchased and the number of grinded rail will be doubled (from 800 to 1600 runs per mile each year).
